Contract #: 04-0120F4Cty: SF/ALA Rte: 80 PM: 13.2/13.9File #: 69.28**WELDING INSPECTION REPORT****Resident Engineer:**Siegenthaler, Peter**Address:** 333 Burma Road**City:** Oakland, CA 94607**Report No:** WIR-021618**Date Inspected:** 12-Feb-2011**Project Name:** SAS Superstructure**OSM Arrival Time:** 700**Prime Contractor:** American Bridge/Fluor Enterprises, a JV**OSM Departure Time:** 1900**Contractor:** Zhenhua Port Machinery Company, Ltd (ZPMC), Changxing Island **Location:** Shanghai, China**CWI Name:** Lv Li Qing**CWI Present:** Yes No**Inspected CWI report:** Yes No N/A**Rod Oven in Use:** Yes No N/A**Electrode to specification:** Yes No N/A**Weld Procedures Followed:** Yes No N/A**Qualified Welders:** Yes No N/A**Verified Joint Fit-up:** Yes No N/A**Approved Drawings:** Yes No N/A**Approved WPS:** Yes No N/A**Delayed / Cancelled:** Yes No N/A**Bridge No:** 34-0006**Component:** OBG**Summary of Items Observed:**

WELDING INSPECTION REPORT

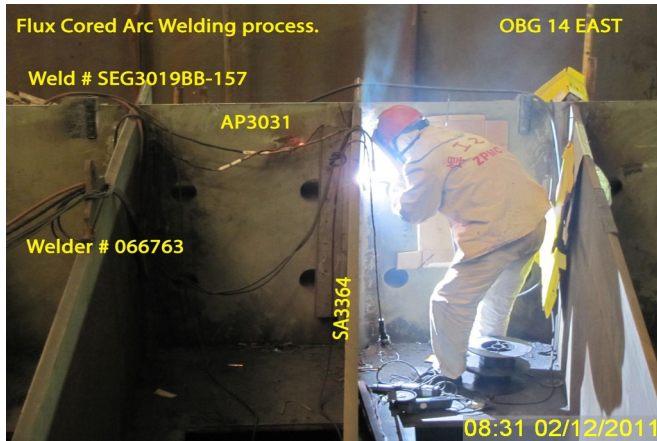
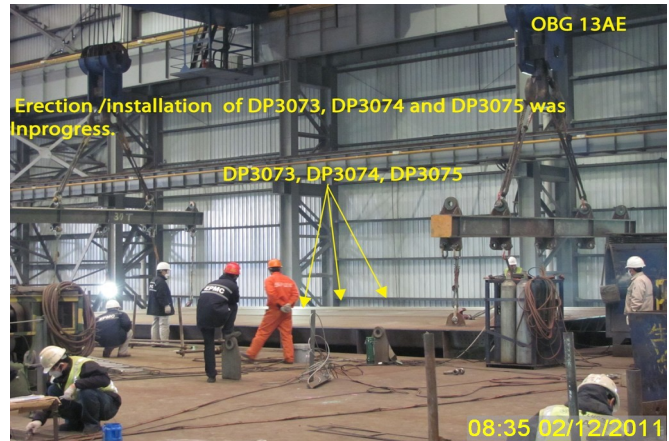
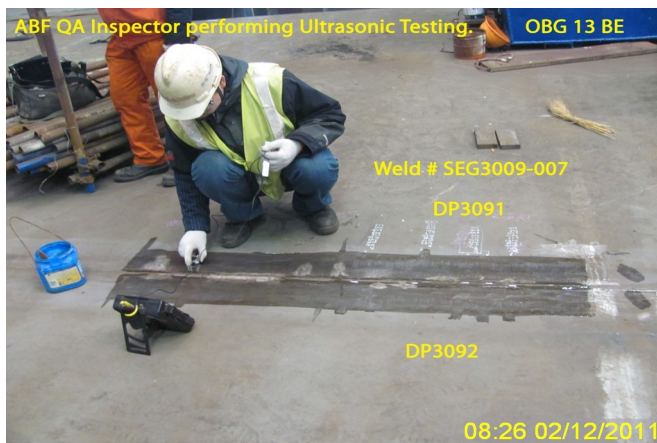
This Quality Assurance (QA) Inspector observed ZPMC qualified welder 058087 performing the Shielded Metal Arc Welding process on weld 169 located at PCMK SEG3019BB. ZPMC QC Mr. Guo Xing Hui was monitoring this welding operation. The welding variables recorded by QC appeared to comply with WPS-345-SMAW-2G (2F)-Fcm-Repair-1. Critical weld repair report identified as B-CWR2737.

This QA Inspector observed ZPMC personnel performing Ultrasonic Testing for the repair areas of the weld between FB3286 and bottom panel, Weld detail as "T" joint CJP weld. Weld number identified as SEG3019D-1-323.

This QA Inspector observed ABF QA Inspector performing Ultrasonic Testing for the deck panel splice between DPDP3091 and DP3092. During the Ultrasonic Testing ABF QA Inspector discovered 17 rejectable longitudinal linear indications. Weld number identified as SEG3009-007.

This QA Inspector observed erection/installation of deck panels DP3074, DP3073, DP3075 was in progress in OBG segment 13AE.
